**RAILWAY INVESTIGATION REPORT**  
**R05T0030**

**PEDESTRIAN FATALITY**

**CANADIAN NATIONAL**  
**FREIGHT TRAIN Q-106-41-15**  
**MILE 124.88, KINGSTON SUBDIVISION**  
**BROCKVILLE, ONTARIO**  
**17 FEBRUARY 2005**

Report Number R05T0030

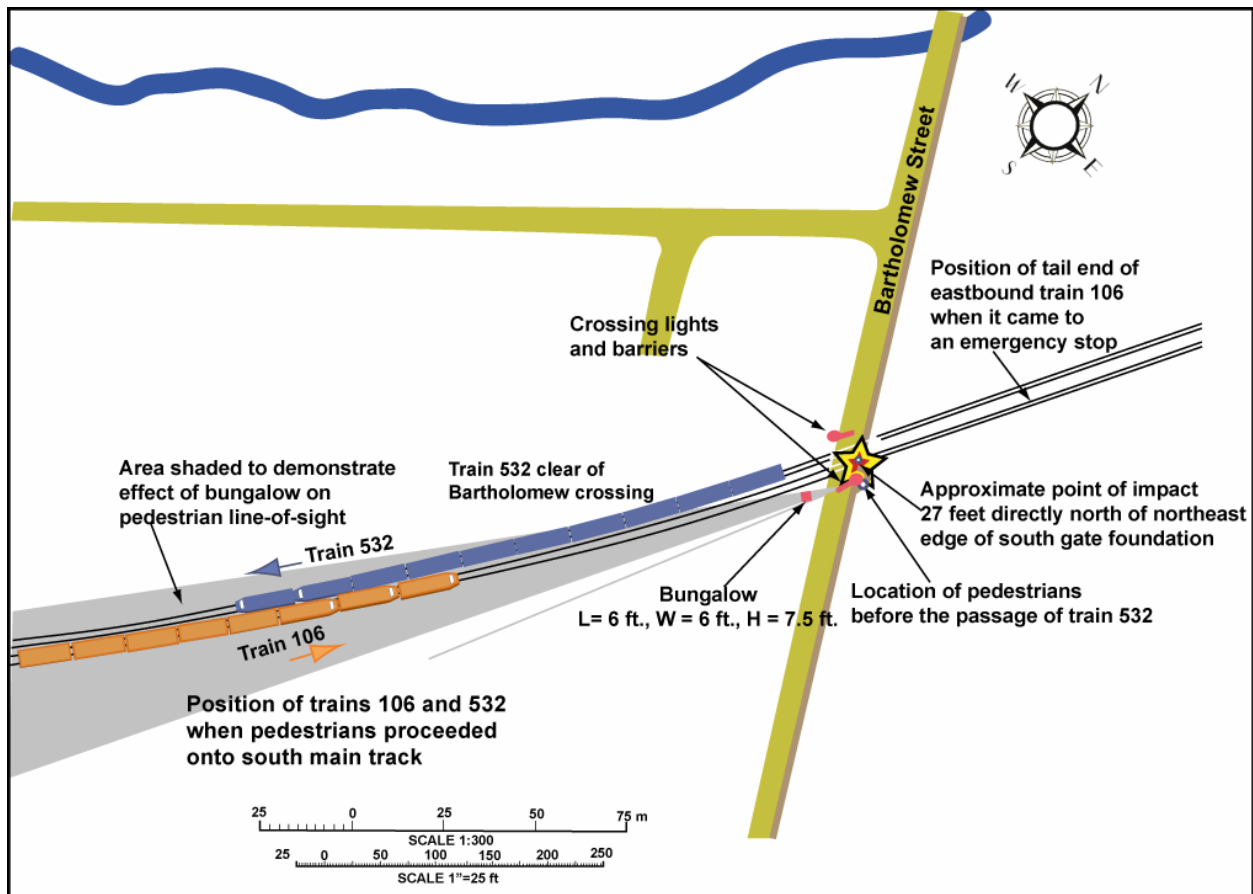
Canadian National (CN)<sup>1</sup> freight train Q-106-41-15 (train 106), travelling eastward on the south main track, approached the Bartholomew Street public crossing at 60 mph. At the same time, westward CN freight train 532, proceeding on the north main track at 40 mph, had nearly completed traversing the crossing. Two young girls were standing on the sidewalk clear of the south main track and on the east side of the street (see Figure 1). They were standing directly east of the crossing gate mechanism, facing north and looking east toward the approaching rear of train 532. As the rear car of train 532 cleared the crossing, the two pedestrians began walking north onto the south track where they were struck by train 106. At the time of the accident, the roadway gates were down and the flashing lights and bell were operating.

**Figure 1.** South main track and east side of the street

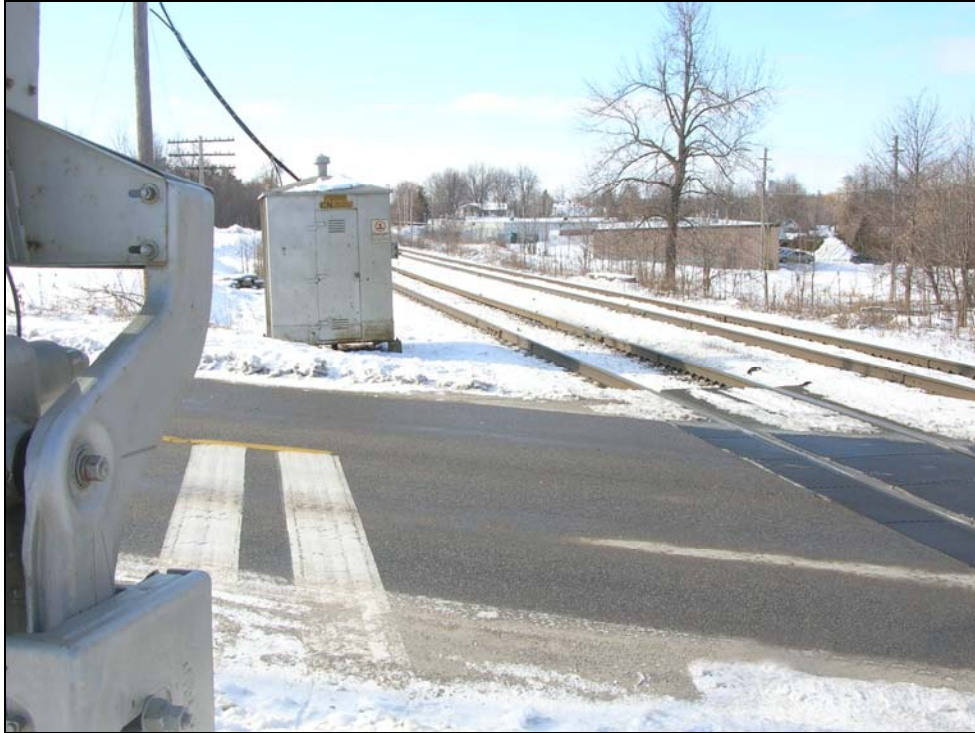
There are no signs, barriers or visual aids to indicate a safe distance for pedestrians to remain back from the track when trains are approaching. For some locations south of the signal apparatus, the sightlines are unrestricted. However, from the location where the two pedestrians were standing before proceeding onto the track, the view to the west was limited to less than 100 feet because of the location of the signal bungalow (seven feet from the rail) and the gate protection control mechanism (see Photo 1). This is the location where the majority of northbound pedestrians were observed to stand while waiting for a train movement to clear the crossing. The signal bungalow<sup>2</sup> is located 7.17 feet (2.18 m) south of the nearest rail.

**Photo 1.** View looking west from sidewalk in southeast quadrant of the Bartholomew Street level crossing

Existing TC sightline regulations only pertain to vehicular traffic. There are currently no regulations governing pedestrian sightlines. At the Bartholomew crossing, the westward view of the south track in the vicinity where the two girls were observed to be standing is restricted. The girls were adjacent to the east side of the signal mechanism where other pedestrians were observed to stand. A signal bungalow further restricts a pedestrian's view of the west side of the south track.

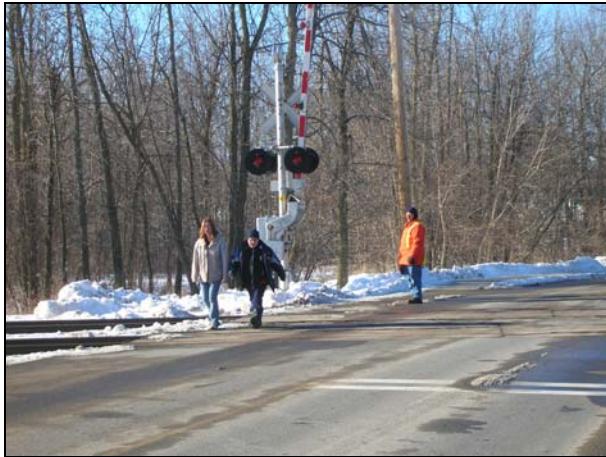
**Photo 2.** Crossing guard at Boundary Road public crossing at grade in Prescott, Ontario

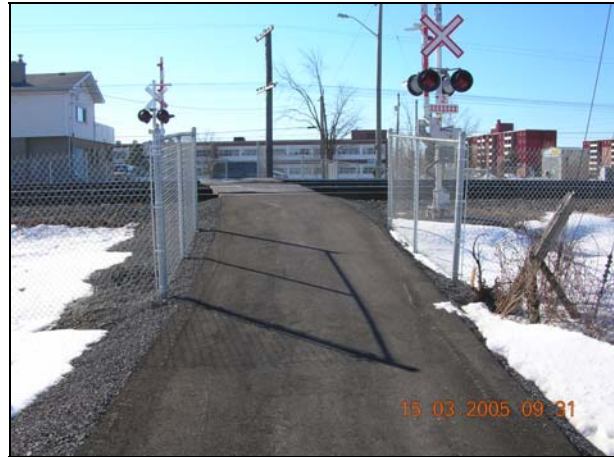
**Photo 3.** Pedestrian only crossing near school in Kingston, Ontario

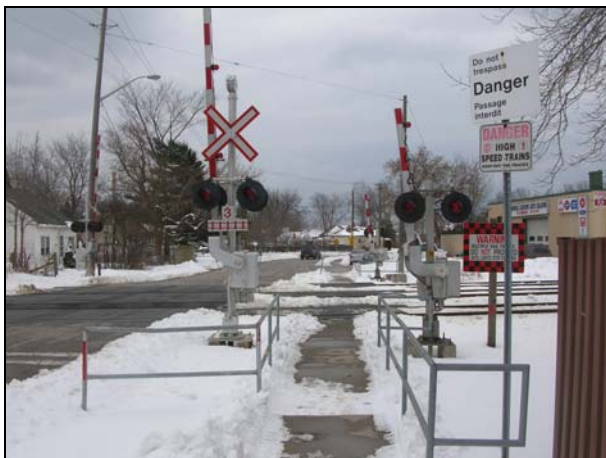
**Photo 4.** Pedestrian gate installation at Alexandra Road crossing at grade along the Oakville Subdivision in Mississauga, Ontario

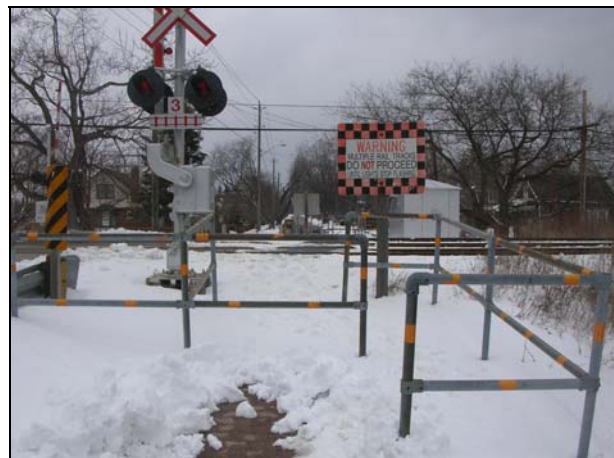
**Photo 5.** Pedestrian maze gates installation along the Oakville Subdivision in Mississauga, Ontario
